# Eugene Water & Electric Board

## Transmission Main Condition Assessment

Nathan W. Endicott P.E., Staff Engineer  
PNWS AWWA, 2017

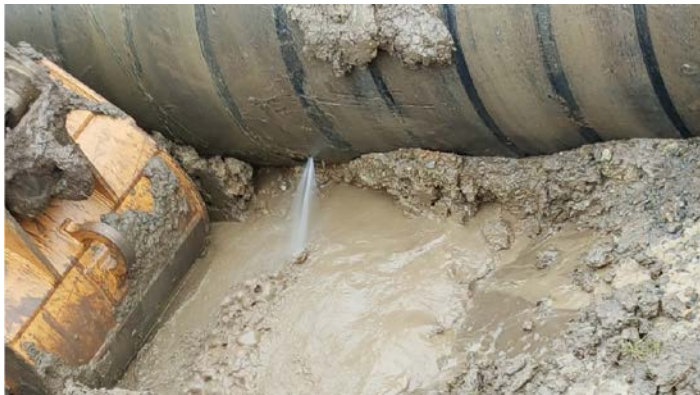
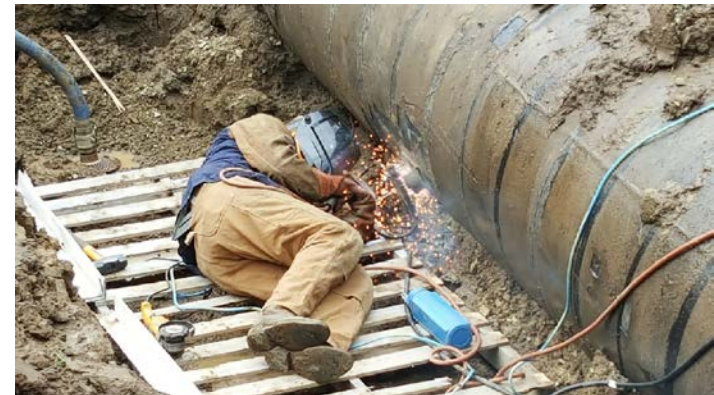
- On April 11, 2016 a leak was discovered on EWEB's 45-inch transmission line near the Treatment Plant.
- The welder made multiple patch repairs where pitting was evident and the crew noticed coating separating from the main on the bottom of the pipe.

**68 year old 45-inch Steel Pipe – localized corrosion failure**

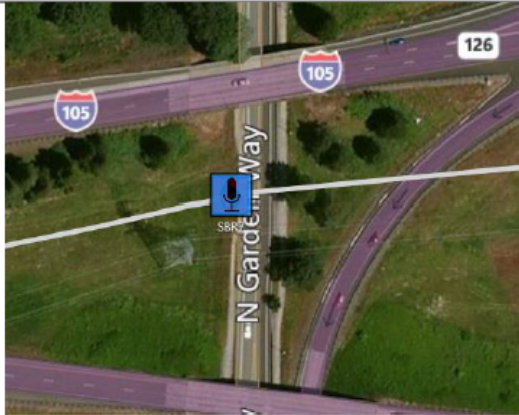
| 45-INCH : Leak #1 | |

| 45-INCH : Leak #1 | |
|---|---|
| Leak Distance from Nearest Tracking Location | 1 feet after SBR 7 (12-inch Gate Valve at Station 102+39, from drawing D-1124) |
| Leak Distance from Nearest Tracking Location | 2197.1 feet before SBR 8 (exposed pipe ~135 feet downstream of University Commons Road) |
| Leak Size | Small (~1.36 gal/min) |
| Leak Details | Suspected Feature – Related Leak |
| Leak Location Description | Leak location lines up with SBR 7 on North Garden Way. Possibility that feature was left open during inspection. Mechanical noise heard. No visible cause observed. |
| Location Confidence Comments | High confidence location due to the proximity to SBR 7. |

- Overall, both the 45-inch and the 30-inch transmission mains show indications of being in good condition.
- The acoustic anomalies detected were correlated with water system features (valves).
- EWEB intends to inspect each valve to assure that there are no leaks.

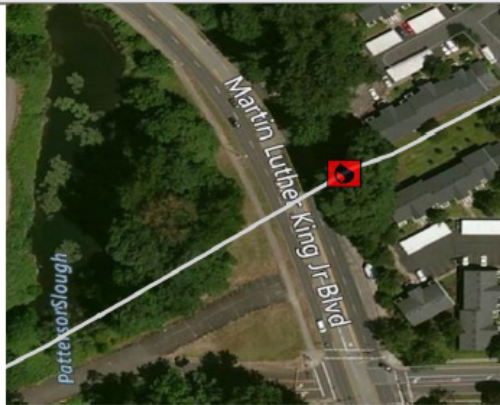
| 45-INCH : Leak #2 | |

| 45-INCH : Leak #2 | |
|---|---|
| Leak Distance from Nearest Tracking Location | 978.3 feet after SBR 8 (exposed pipe ~135 feet downstream of University Commons Road) |
| Leak Distance from Nearest Tracking Location | 1295.6 feet before SBR 9 (next to Autzen Stadium) |
| Leak Size | Small (~0.04 gal/min) |
| Leak Details | Suspected Feature – Related Leak |
| Leak Location Description | Leak is located ~978 feet downstream of SBR 8 and is suspected to be related to a feature right next to Martin Luther King Jr Boulevard. |
| Location Confidence Comments | Medium confidence location since the leak is within SBR 8 tracking range. |

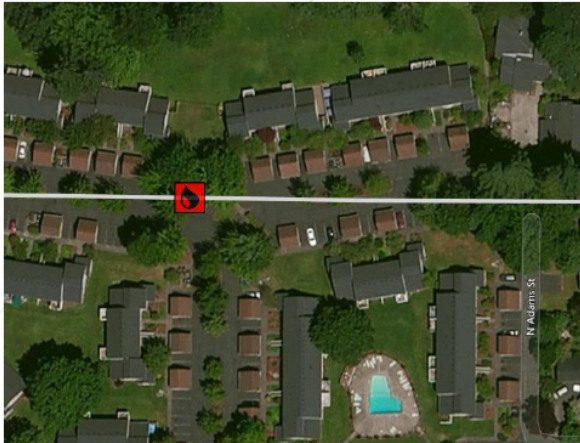
| 30-INCH Leak #1 | |

| 30-INCH Leak #1 | |
|---|---|
| Leak Distance from Nearest Upstream Tracking Location | 1233.6 feet after SBR 2 (2-inch Valve Air Bleed and Intake at Station 89+95, from drawing D-5335-9) |
| Leak Distance from Nearest Downstream Tracking Location | 602.9 feet before Extraction (6-inch Flange Outlet and Valve at Station 107+45, from drawing D-5335-10) |
| Leak Size | Small (~0.85 gal/min) |
| Leak Details | Suspected Feature-Related Leak. Event lines up with a 6-inch cast iron lateral connection. This feature could have been open during the inspection |
| Leak Location Description | The leak is located ~603 feet upstream of Extraction and lines up with a 6-inch cast iron lateral connection. |
| Location Confidence Comments | High confidence location due to proximity to Extraction. |
